Repair of Icom IC-28A, -28H squelch pot plus battery replacement

by Richard L. Carey, W6RLC, April 19, 2014, revised Dec. 4, 2015 (See note at the end)

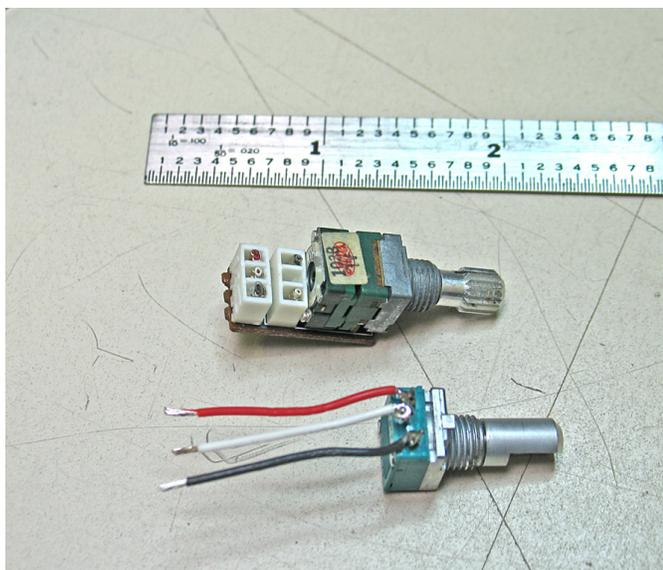
The replacement part is No. RK097111080J by Alps which is available from Mouser for \$1.74. I didn't worry about the taper. The pot has a 7 mm mounting bushing and a 15 mm shaft which works out well with no cutting of the shaft required. The photo shows the Icom part and its replacement.

I soldered on some 24Ga wires before installation. The colors match those Icom uses.

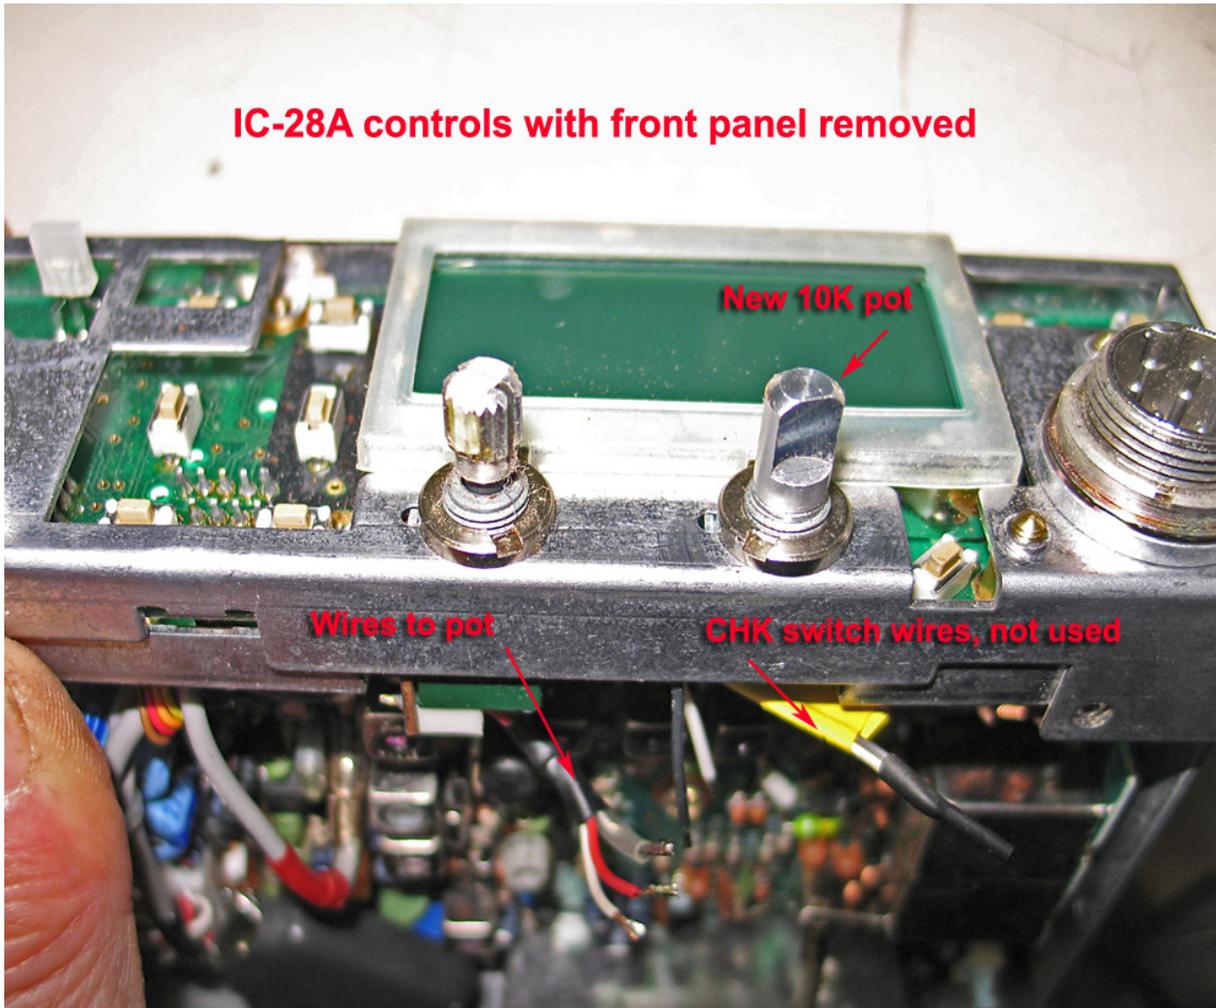
The above photo shows the new pot in place, but the leads have not yet been connected to those in the radio. With the pot wired in you can replace the front panel. The volume and squelch knobs had a small amount of adhesive tape on them. There was some still inside the squelch knob which should be removed. The pot shaft is 0.236 inch diameter so I used a number "A" drill which is 0.234 inch. I twisted it inside the knob by hand to clean it out and remove the glue. The Icom knob fit on snug and looks like it will stay without any glue.

Install new pot: With the short pigtail leads soldered onto the pot I fastened it onto the front panel using the Truarc plier. The pot has a small alignment tab which fits perfectly into a small hole in the front panel preventing rotation of the pot. I then put 1/16 inch shrink tubing on the red and white wires and 1/8 inch on the black which connects to the shield. Solder these leads to the leads in the radio. I was afraid to use the heat gun on these leads so I just slipped them over the joints and used some lacing cord to hold them in place.

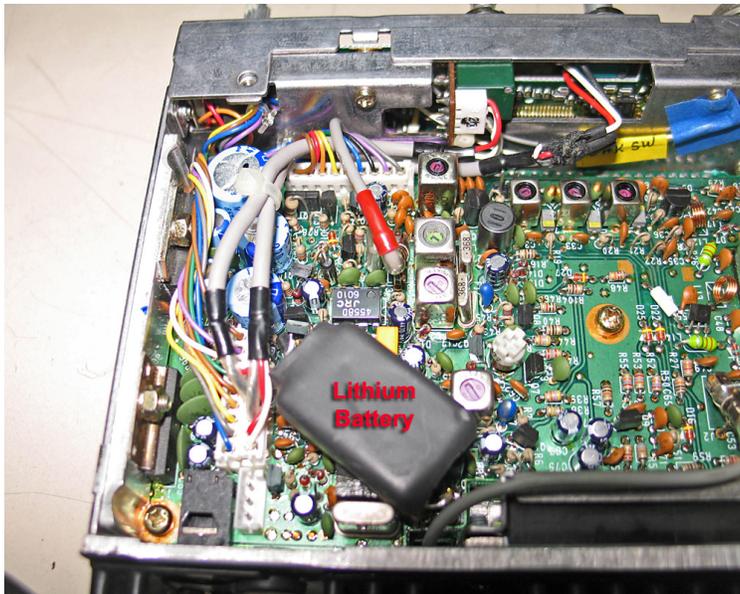
Icom IC-28A bottom circuit board showing the lithium battery wrapped in shrink tubing. The red and white wires at the top coming out of the front panel are the wires to the new pot.

The new Tadrian battery is cylindrical and thicker so to make it fit I removed a piece of foam that was underneath the battery. It fits in OK then setting on top of the MC3357 chip. See the photos.

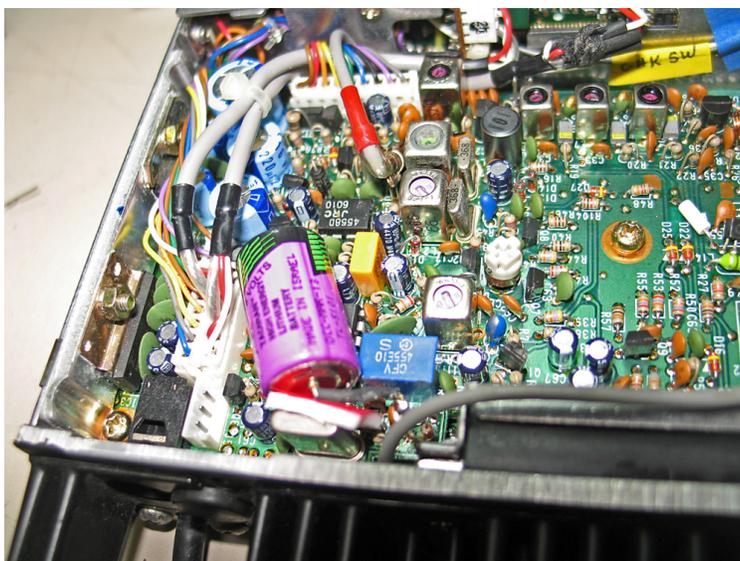
The new battery in place.

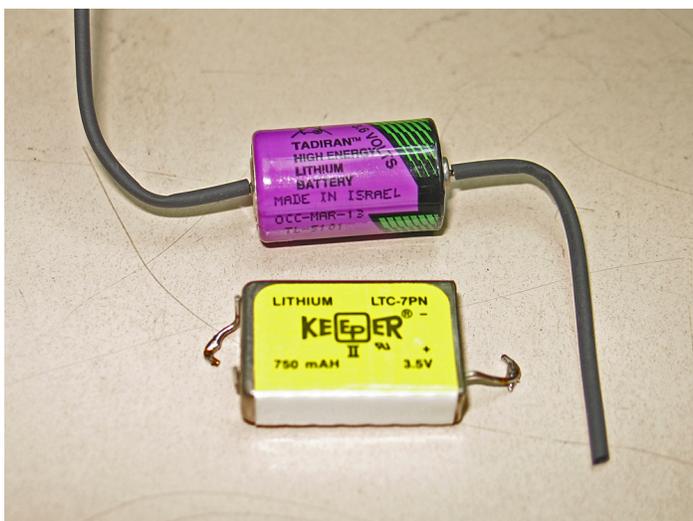
Tadrian battery on top and original Icom battery below.

Battery Replacement: Since the battery was more than 20 years old I decided to replace it even though it still measured 3.6V. The exact battery can be found at Mouser for \$19.07, but I found a lithium cell by Tadrian at a local store here in San Diego that was about \$7.00. It is called Ultralast No. TL-5101/P.

It has solder leads which are necessary for connection to wires in the radio. Its capacity is 950 mAh which is more than the 750 mAh battery it replaces.
